Risk Control Survey

Powell River Regional District

Surveyed by: Kyle Martin

Reference #: 1957581

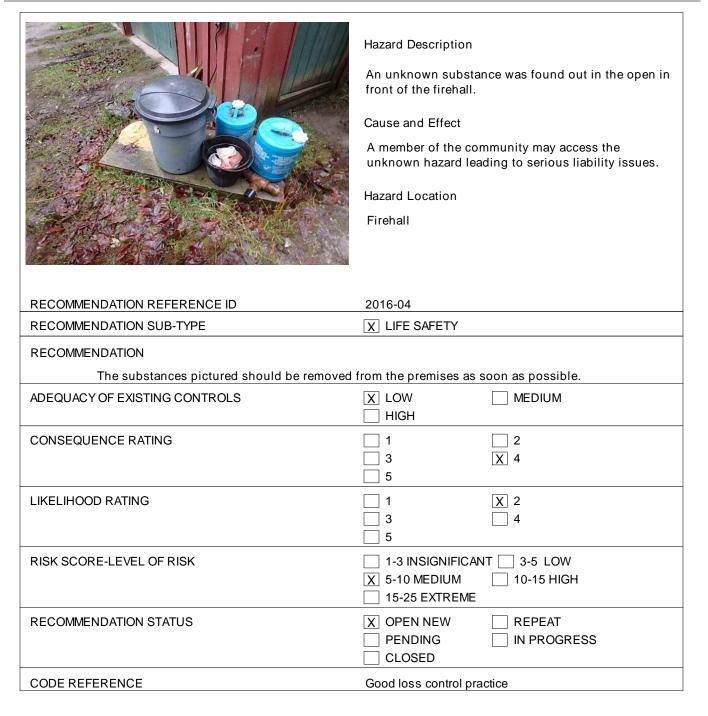
2.4 RECOMMENDATION

RISK EVALUATION		
The following recommendations were made:		
2016-01 - Consider adjusting the access points of the Firehall and Recycling Depot 2016-02 - Close junction box in Firehall 2016-03 - Ladder access at rear of Firehall 2016-04 - Remove chemicals found outside of Firehall 2016-05 - Enclose outhouse at Firehall 2016-06 - Address Housekeeping at the Recycling Depot 2016-07 - Remove nails found at the Free store 2016-08 - Install handrails as needed

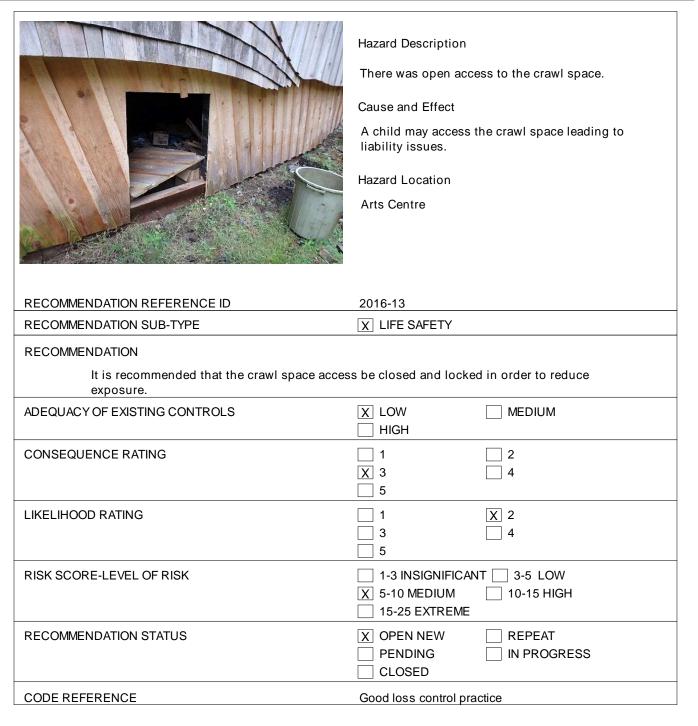
2.13 RECOMMENDATION

- 2016-09 Install slip protection as needed
- 2016-10 Address hazards found at the long term parking lot
- 2016-11 Address layout of the long term parking area
- 2016-12 Remove debris/wood from the Arts Centre property
- 2016-13 Close crawl space area at Arts Centre
- 2016-14 Update play equipment at the playground
- 2016-15 Update signage at the playground

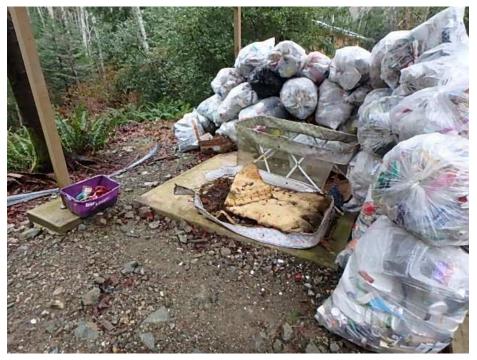
See recommendation 2016-06

<image/>	 Hazard Description The premises are overrun with excess recycled items. Cause and Effect The recyclables have not been removed in a long time and the area is being overrun with materials, which has resulted in poor housekeeping and many hazards around the area. Hazard Location Recycling Depot 	
RECOMMENDATION REFERENCE ID	2016-06	
RECOMMENDATION SUB-TYPE	SNOW REMOVAL X HOUSEKEEPING GENERAL STORAGE	
RECOMMENDATION		
The recycling area has been noted to be poorly maintained. The housekeeping is not adequate and the good have not be removed in a timely manner leading to an excess of items onsite. These include sharp metal, broken glass and allurements. The area needs to be cleaned up and reorganized in order to reduce possible future liability issues.		
ADEQUACY OF EXISTING CONTROLS	X LOW MEDIUM HIGH	
CONSEQUENCE RATING	□ 1 □ 2 □ 3 X 4 □ 5	
LIKELIHOOD RATING	□ 1 □ 2 X 3 □ 4 □ 5	
RISK SCORE-LEVEL OF RISK	 ☐ 1-3 INSIGNIFICANT ☐ 3-5 LOW ☐ 5-10 MEDIUM X 10-15 HIGH ☐ 15-25 EXTREME

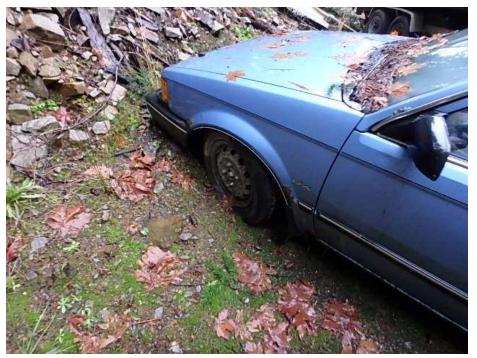
See recommendation 2016-10

Hazard Description There were a number of broken down, rusted old cars in the parking lot. Cause and Effect These cars are creating an serious liability hazard. Hazard Location Long term parking	
RECOMMENDATION REFERENCE ID	2016-10	
RECOMMENDATION SUB-TYPE	X LIFE SAFETY	
RECOMMENDATION It is recommended that any broken down, unfit cars be removed from the parking lot. These include any cars with broken windows, flat or removed tires (some are on blocks) or any		
cars that have been abandoned. These cars if a member of the public comes into contact	may lead to an unnecessary liability exposure t with them.	
ADEQUACY OF EXISTING CONTROLS	X LOW MEDIUM HIGH Image: Second secon	
CONSEQUENCE RATING	□ 1 □ 2	
	□ 3 X 4 □ 5	
LIKELIHOOD RATING	□ 1 □ 2 X 3 □ 4 □ 5	
RISK SCORE-LEVEL OF RISK	1-3 INSIGNIFICANT 3-5 LOW 5-10 MEDIUM X 10-15 HIGH 15-25 EXTREME	
RECOMMENDATION STATUS	X OPEN NEW REPEAT PENDING IN PROGRESS CLOSED

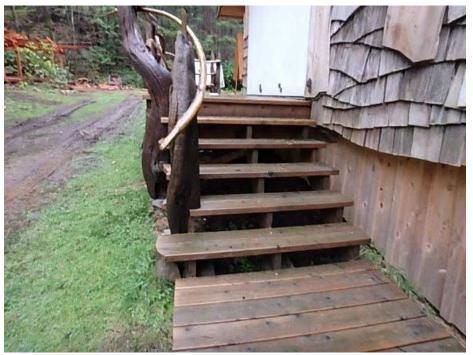
See recommendation 2016-09

Hazard Description The building's exterior stairs lack a slip resistant surface finish. Cause and Effect This creates an unsafe condition and an unnecessary liability hazard. Hazard Location Free Store and Arts Centre
RECOMMENDATION REFERENCE ID	2016-09
RECOMMENDATION SUB-TYPE	X SLIP, TRIP AND FALL
RECOMMENDATION All exterior stairs should be provided with a s resistant strips to prevent slipping and falling ADEQUACY OF EXISTING CONTROLS	
CONSEQUENCE RATING	□ 1 X 2 □ 3 □ 4 □ 5 4
LIKELIHOOD RATING	□ 1 X 2 □ 3 □ 4 □ 5
RISK SCORE-LEVEL OF RISK	1-3 INSIGNIFICANT X 3-5 LOW 5-10 MEDIUM 10-15 HIGH 15-25 EXTREME
RECOMMENDATION STATUS	X OPEN NEW REPEAT PENDING IN PROGRESS CLOSED
CODE REFERENCE	Good loss control practice

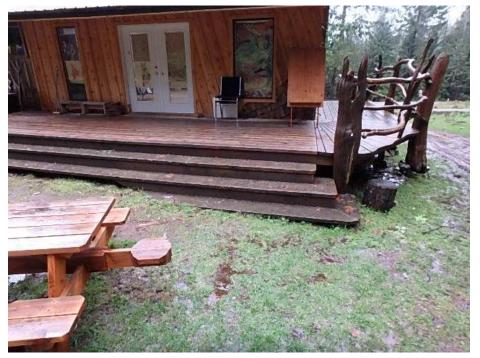
See recommendation 2016-08

Hazard Description It was noted that the ramp (Free Store) and the steps (Arts Centre) which provides building access does not have an adequate handrail. Cause and Effect The lack of handrails may result in fall injuries to persons unable to steady themselves as they descend the ramp/stairs. Hazard Location Free store and Arts Centre
RECOMMENDATION REFERENCE ID	2016-08
RECOMMENDATION SUB-TYPE	X SLIP, TRIP AND FALL
RECOMMENDATION	
To reduce the risk of trip and fall accidents, i that all ramps/stairs with more than 3 risers b	njuries and associated liability, we recommend e provided with handrails.
ADEQUACY OF EXISTING CONTROLS	LOW X MEDIUM
CONSEQUENCE RATING	□ 1 X 2 □ 3 □ 4 □ 5
LIKELIHOOD RATING	□ 1 X 2 □ 3 □ 4 □ 5
RISK SCORE-LEVEL OF RISK	1-3 INSIGNIFICANT X 3-5 LOW 5-10 MEDIUM 10-15 HIGH 15-25 EXTREME
RECOMMENDATION STATUS	X OPEN NEW REPEAT PENDING IN PROGRESS CLOSED
CODE REFERENCE	Good loss control practice

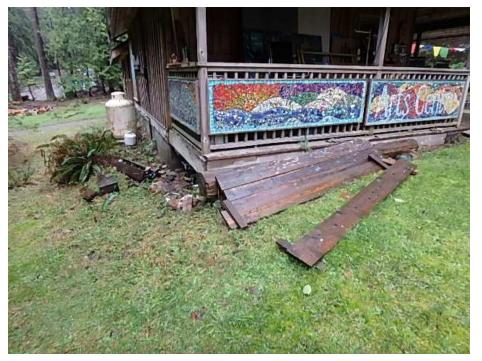
See recommendation 2016-12

Hazard Description Debris was found piled onsite. Cause and Effect A person may injure themselves on the wood debris. Hazard Location Arts Centre
RECOMMENDATION REFERENCE ID	2016-12
RECOMMENDATION SUB-TYPE	X LIFE SAFETY
RECOMMENDATION It is recommended that the debris be remove in order to reduce possible liability exposure	d or moved to a more secure area or into a bin
ADEQUACY OF EXISTING CONTROLS	LOW X MEDIUM HIGH
CONSEQUENCE RATING	□ 1 □ 2 X 3 □ 4 □ 5
LIKELIHOOD RATING	□ 1 X 2 □ 3 □ 4 □ 5
RISK SCORE-LEVEL OF RISK	1-3 INSIGNIFICANT 3-5 LOW 5-10 MEDIUM 10-15 HIGH 15-25 EXTREME
RECOMMENDATION STATUS	X OPEN NEW REPEAT PENDING IN PROGRESS CLOSED
CODE REFERENCE	Good loss control practice

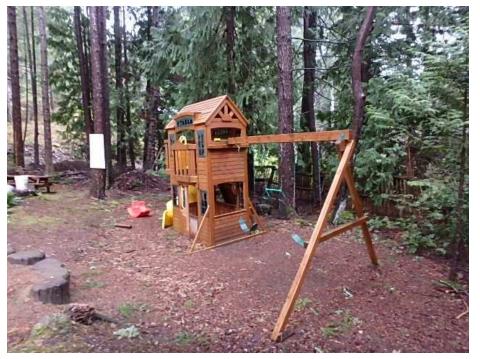
See recommendation 2016-14

Hazard Description The equipment and set up found onsite was not up to current Playspace standards. Cause and Effect The equipment may fail during use and the ground cover is not sufficient. Hazard Location Playground
RECOMMENDATION REFERENCE ID	2016-14
RECOMMENDATION SUB-TYPE	X PLAYGROUND GENERAL
RECOMMENDATION It is recommended that the playground be inspected and updated or replaced in order to configure to the most recent Playspace specifications. Playground equipment should be installed and maintained in accordance with CSA Standard Z614-07, Children's Playspaces and Equipment. In accordance with this standard, we recommend that all playground equipment be surrounded by a minimum of 6' (1.8 meters) of protective surfacing beyond the "Fall Zone" of all playground equipment. This reduces the risk of children falling onto unprotected surfaces (or the edging around the protective surfaces). ADEQUACY OF EXISTING CONTROLS I.OW X MEDIUM

CONSEQUENCE RATING	☐ HIGH ☐ 1 X 2 ☐ 3 ☐ 4 5 ☐ 1 X 2
RISK SCORE-LEVEL OF RISK	3 4 5 1-3 INSIGNIFICANT X 3-5 LOW 5-10 MEDIUM 10-15 HIGH 15-25 EXTREME
RECOMMENDATION STATUS	X OPEN NEW REPEAT PENDING IN PROGRESS CLOSED
CODE REFERENCE	
CAN/CSA Z614-07 "Children's Playspaces and	d Equipment"
